DELAWARE VALLEY WORKS FACILITY  
INTERIM REMEDIAL MEASURE COMPLETION REPORT  
UPPER SLUICeway CLEANOUT  
CLAYMONT, DELAWARE

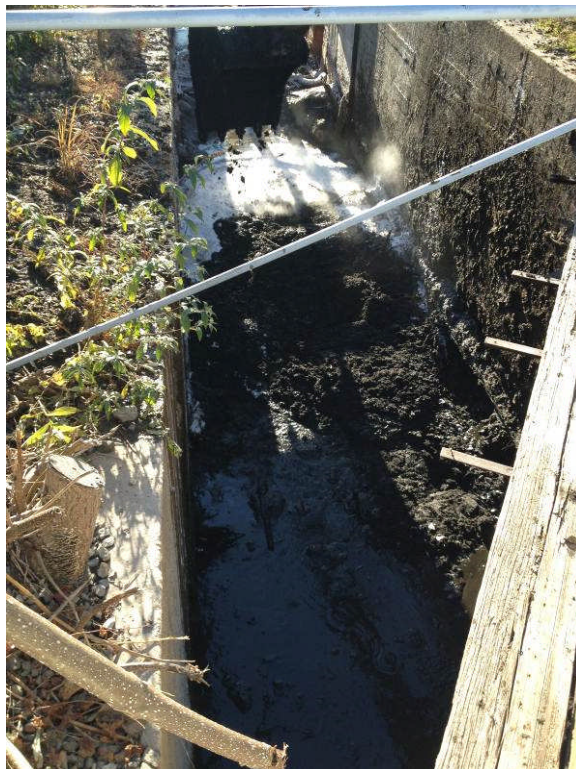
View of SAP being mixed with soft sediment.

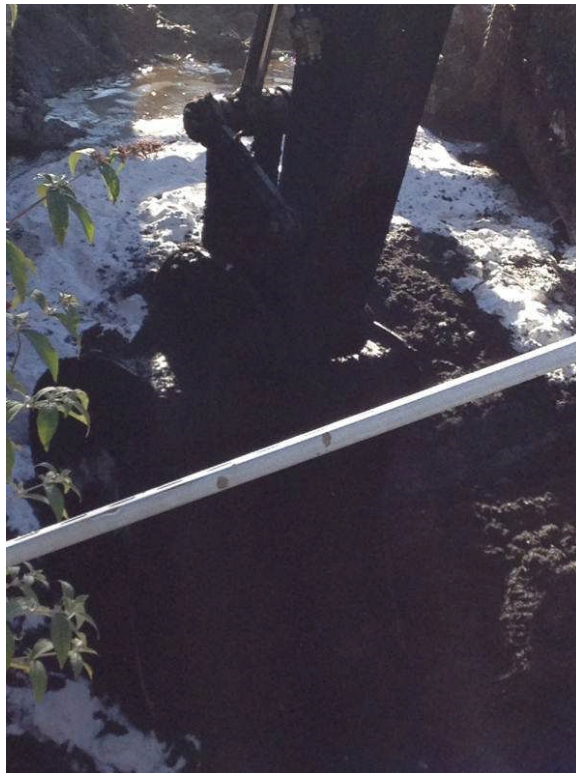
View of SAP being mixed with soft sediment.

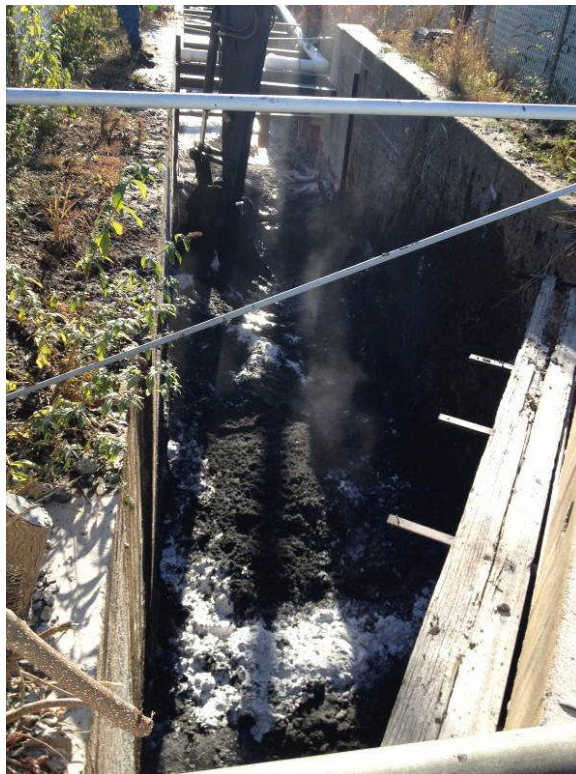
View of SAP being mixed with soft sediment.

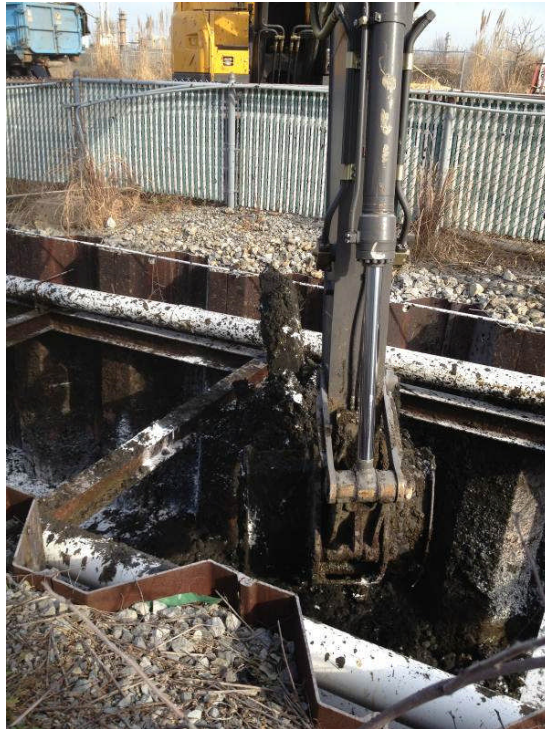
View of stabilized sediment being removed from the upper sluiceway.

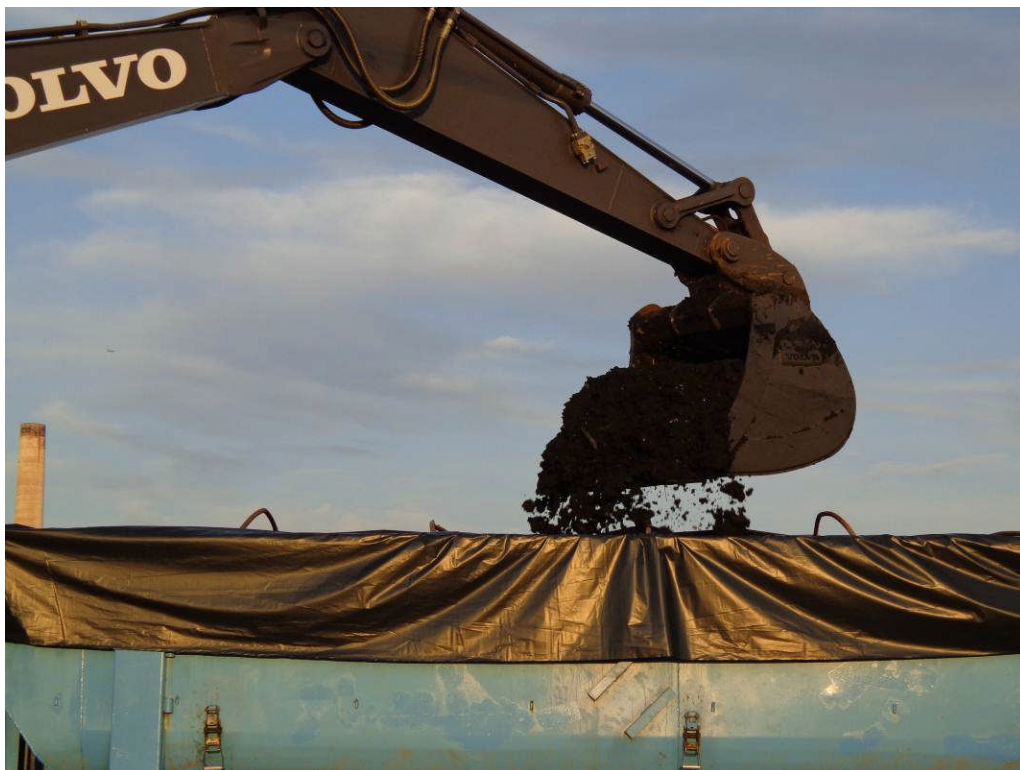
View of the stabilized sediment being placed in a lined rolloff.

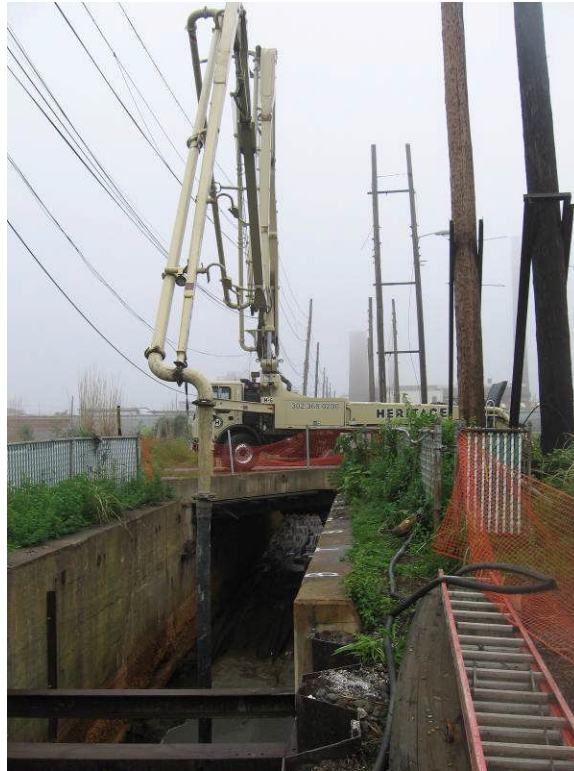
View of the machinery used to pour the CDF.

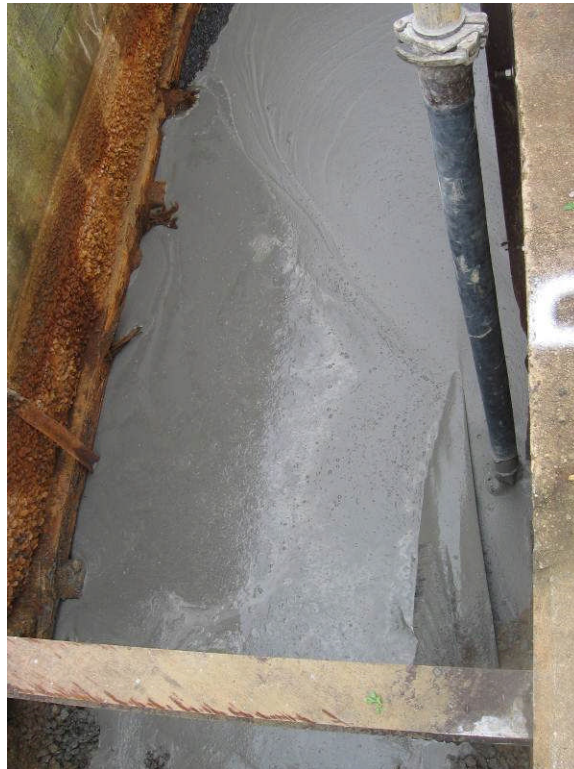
View of CDF being poured below the concrete roadway.

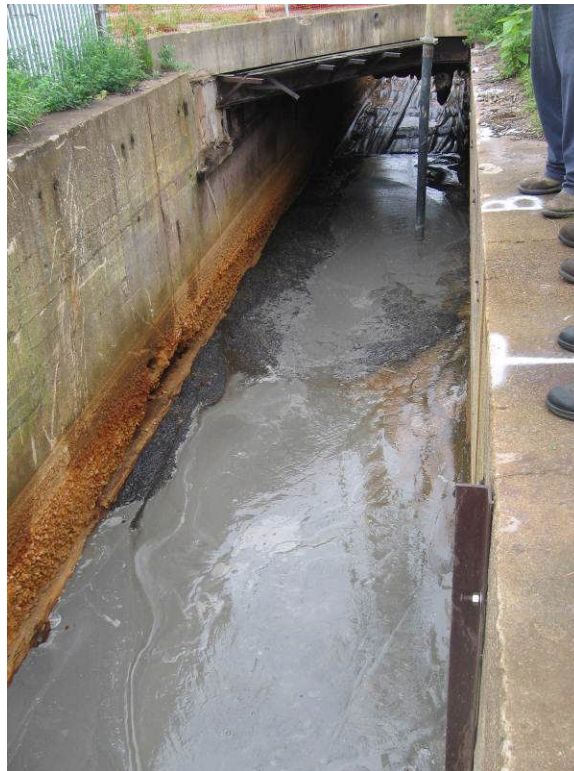
View of CDF being poured below the concrete roadway.

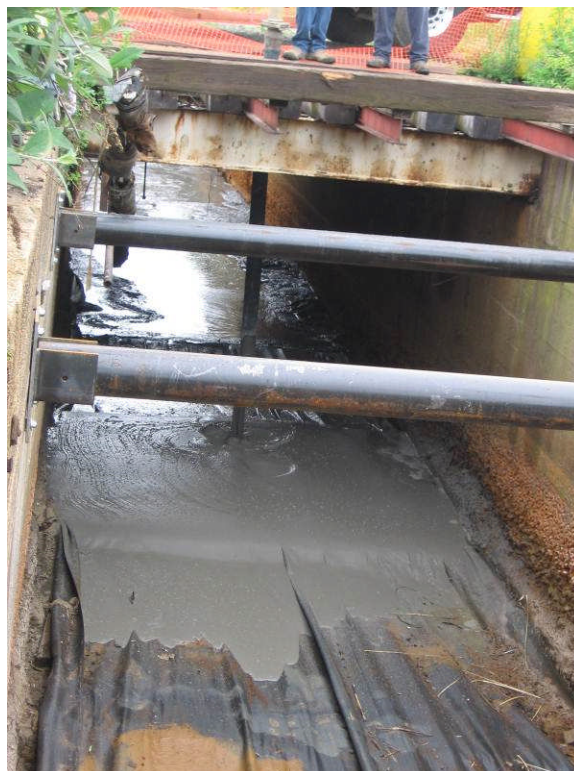
View of CDF being poured above the concrete roadway.

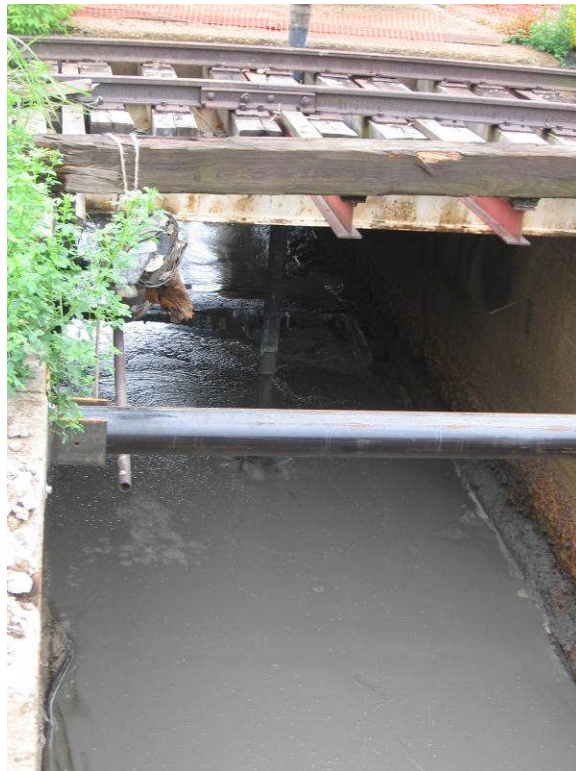
View of CDF being poured above the concrete roadway.

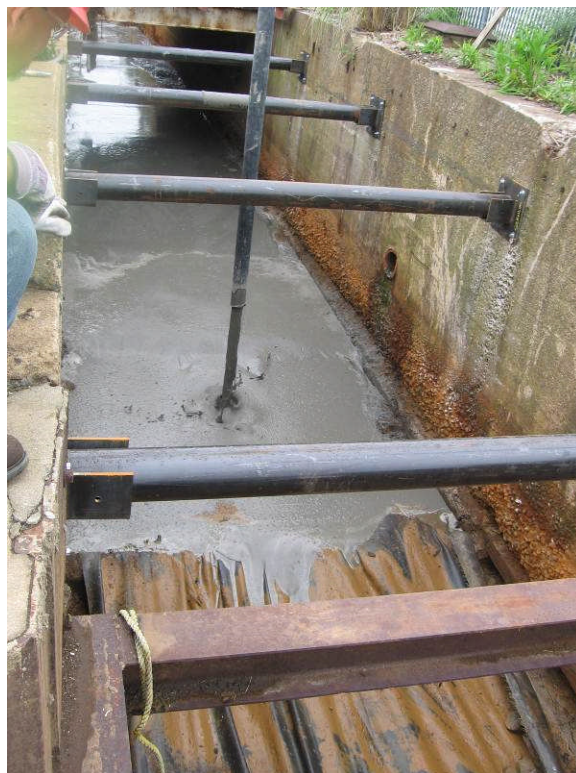
View of CDF being poured above the concrete roadway.

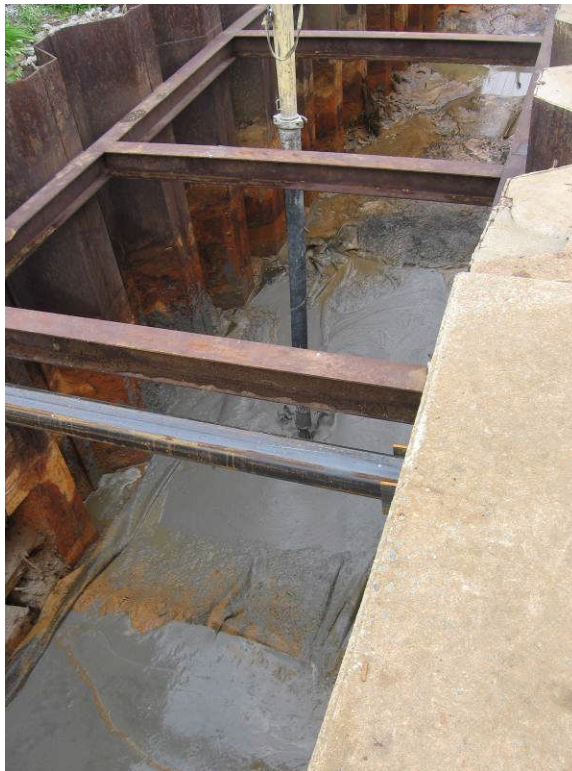
View of CDF being poured above the concrete roadway.

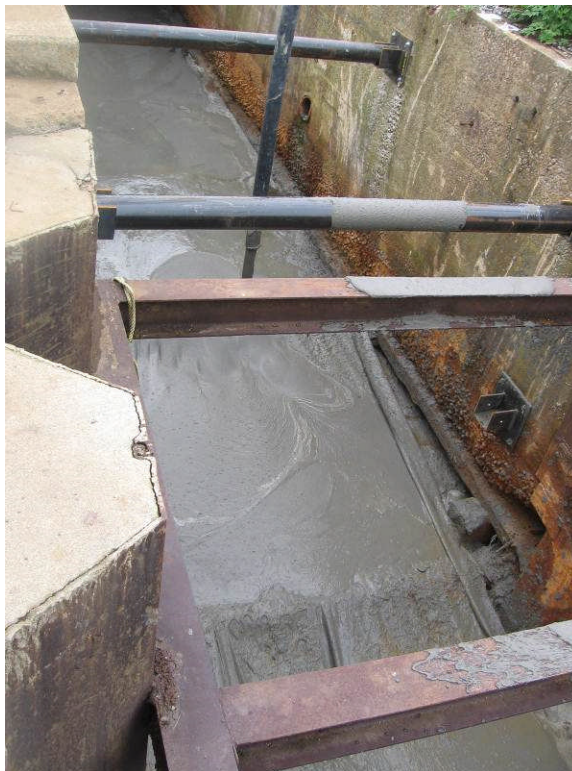
View of CDF being poured above the concrete roadway.

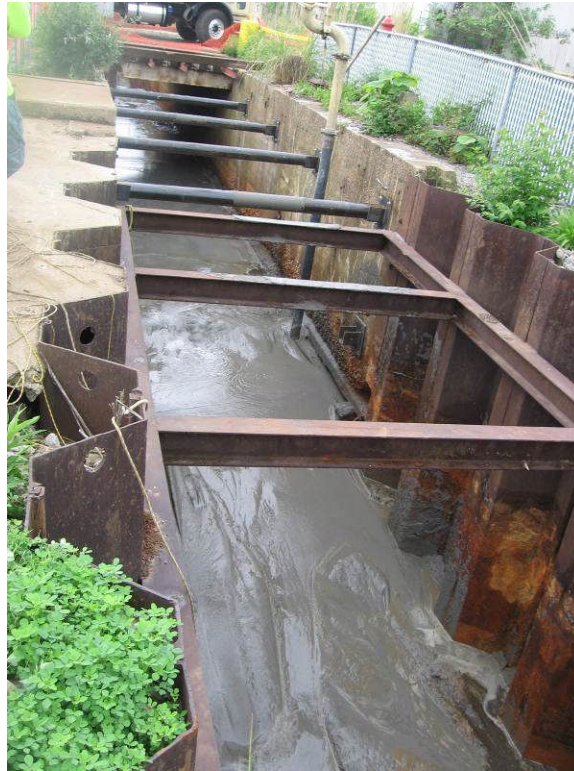
View of CDF being poured above the concrete roadway.

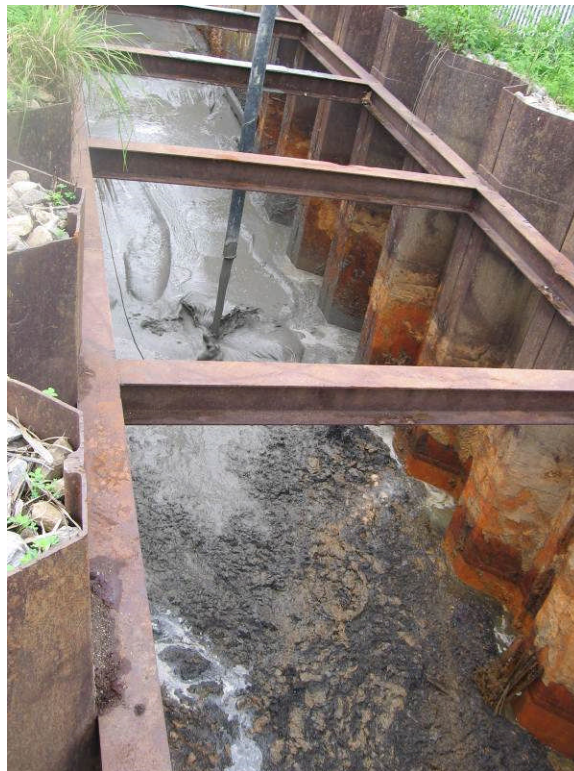
View of CDF being poured above the concrete roadway.

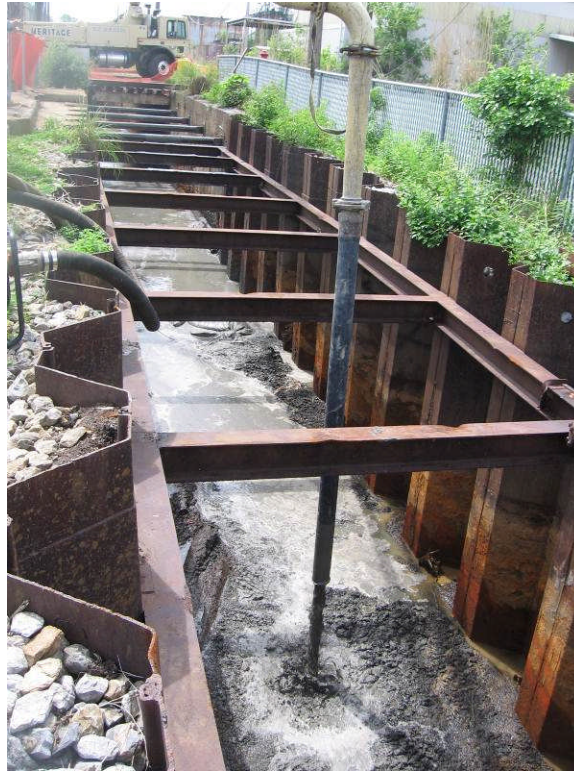
View of CDF being poured above the concrete roadway.

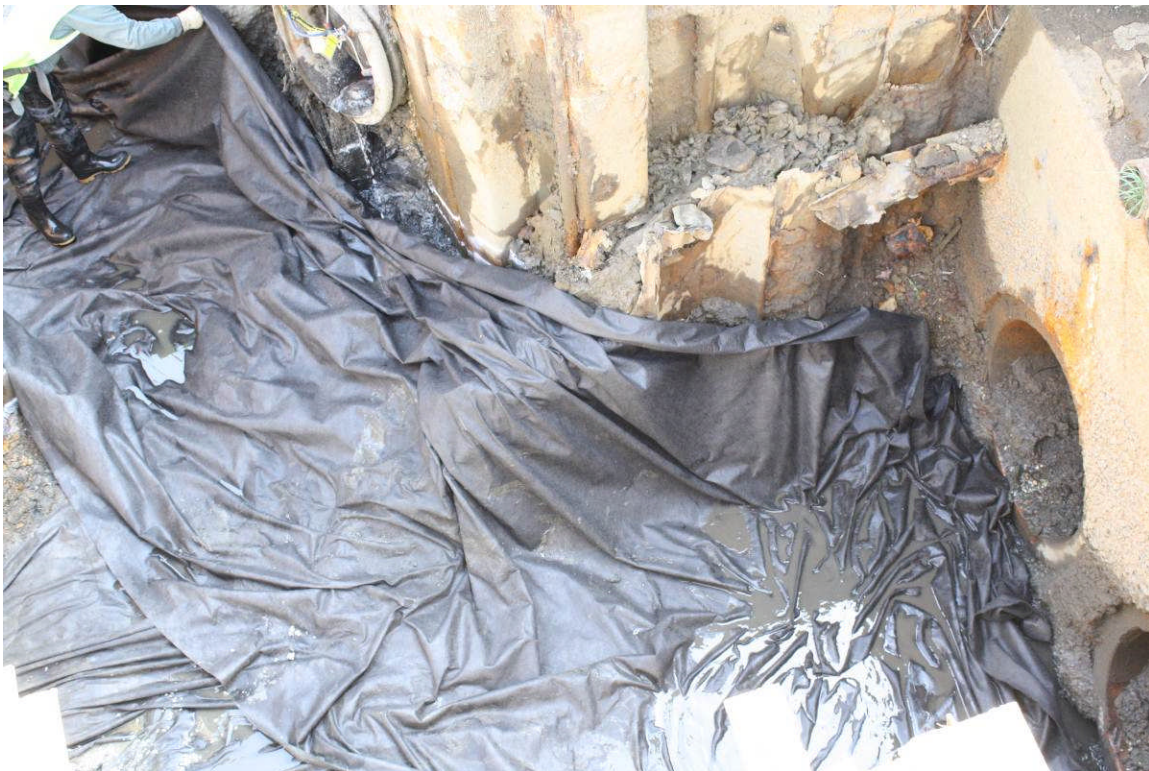
View of the geotextile fabric being placed in the confluence box.

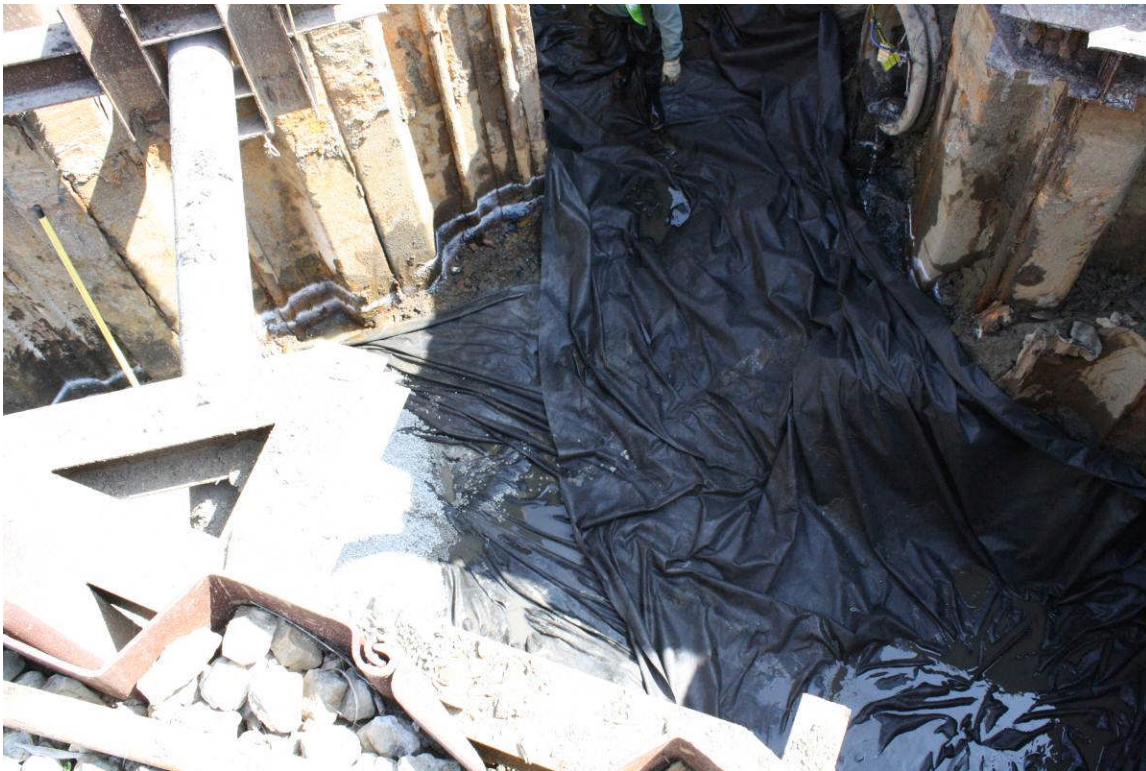
View of the geotextile fabric being placed in the confluence box.

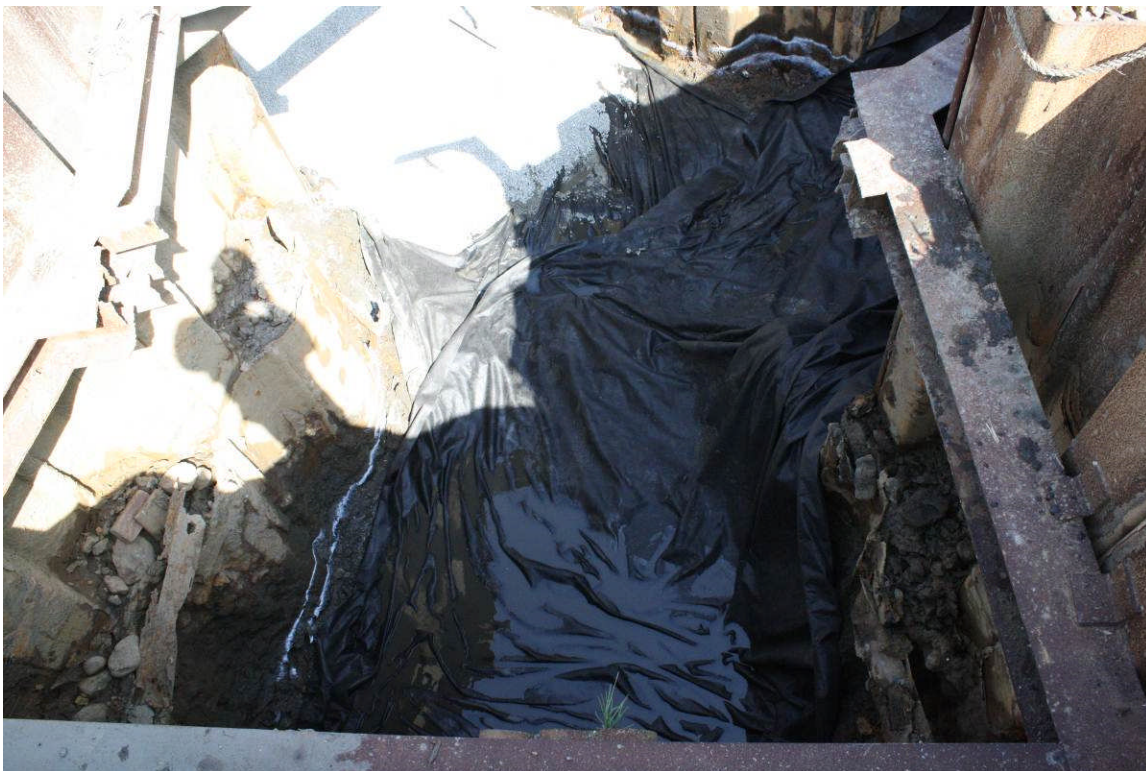
View of the geotextile fabric being placed in the confluence box.

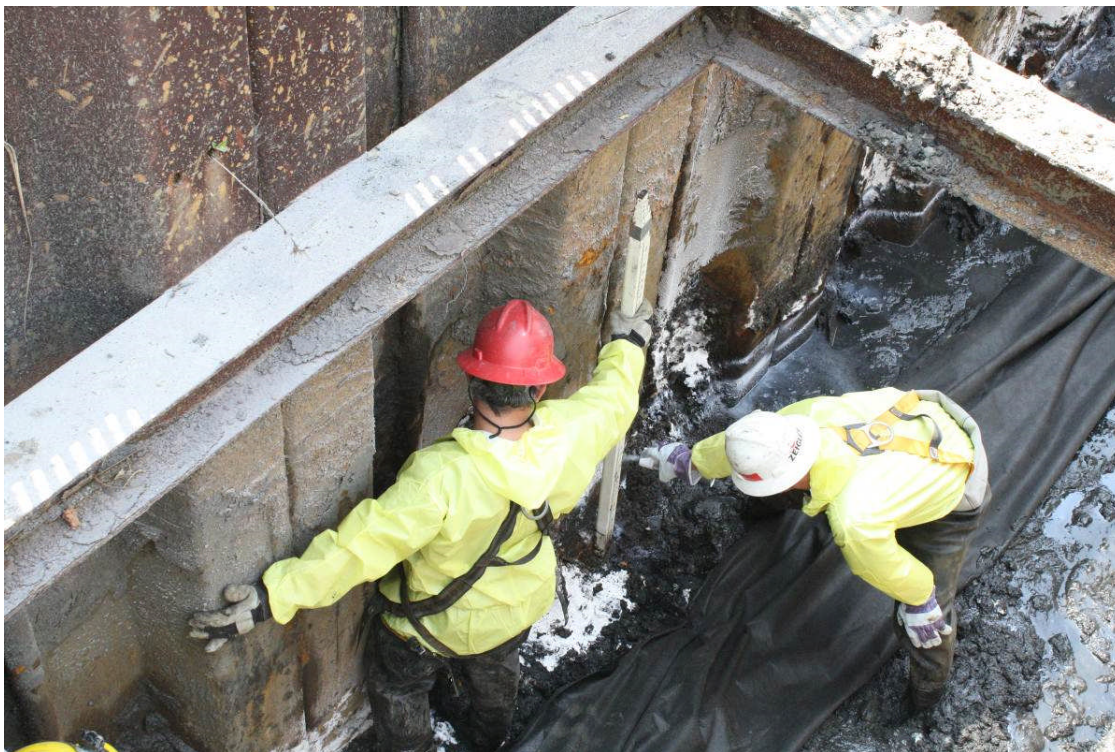
View of the geotextile fabric being placed and markout of the 6 and 12-inch markings on the sidewall to be used for cover installation verification purposes.

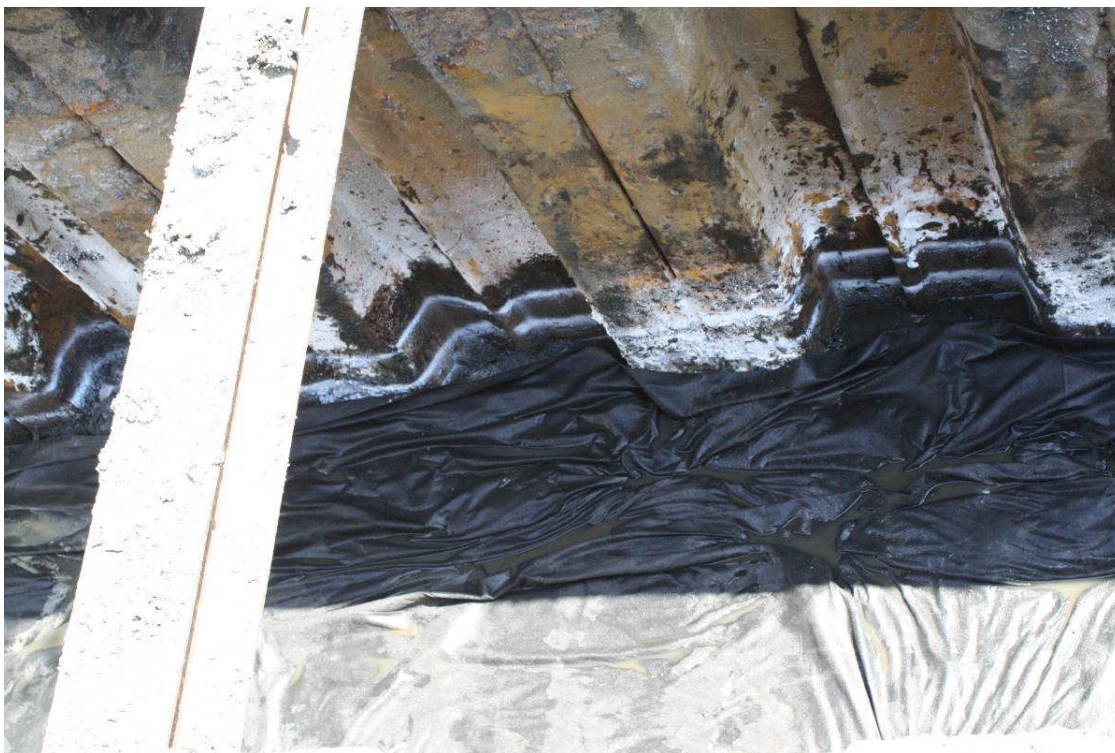
View of the geotextile fabric and the 6 and 12-inch markings on the sidewall prior to cover installation.

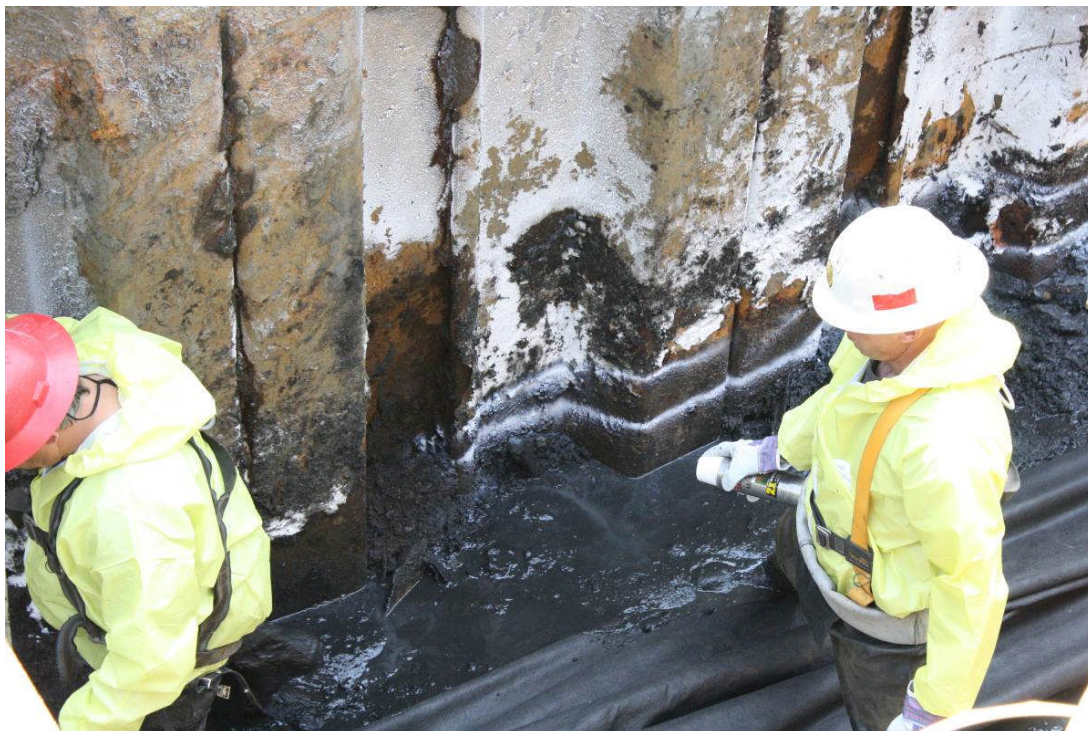
View of the geotextile fabric being placed and markout of the 6 and 12-inch markings on the sidewall to be used for cover installation verification purposes.

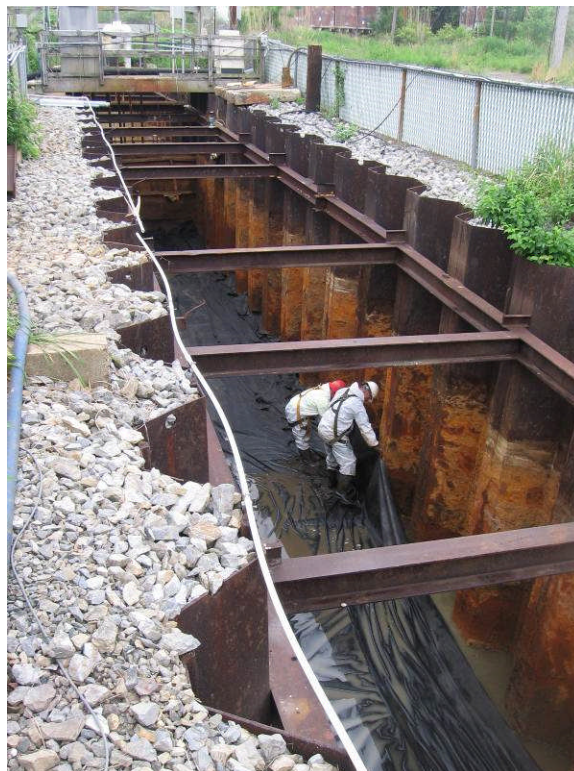
View of the geotextile fabric being installed in the upper sluiceway.

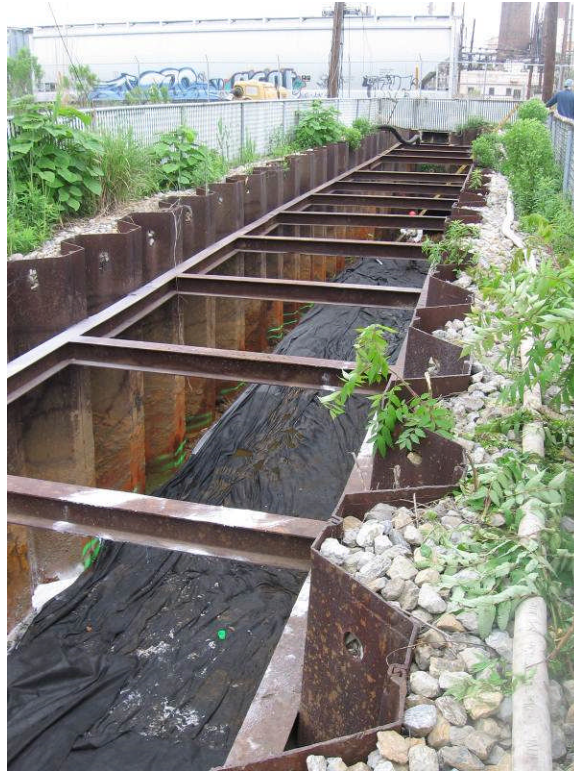
View of the geotextile fabric and the 6 and 12-inch markings on the sidewall prior to cover installation.

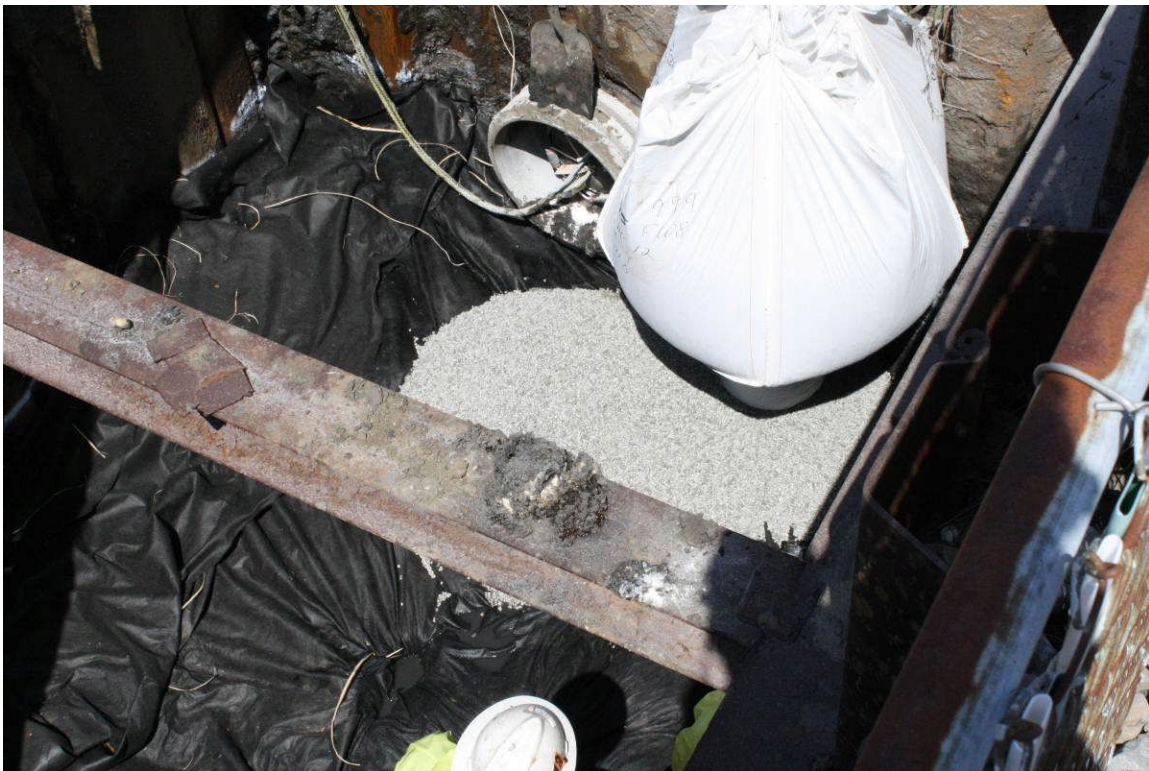
View of the AquaBlok® being poured in the confluence box.

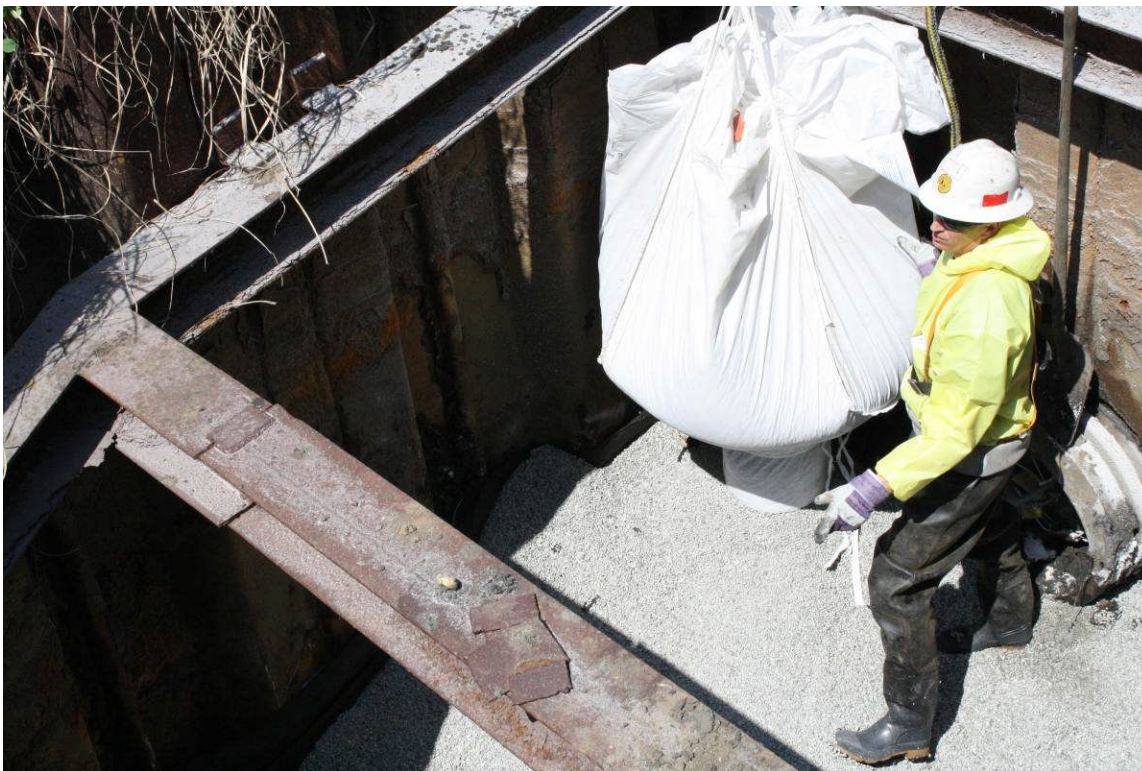
View of the AquaBlok® being poured in the confluence box.

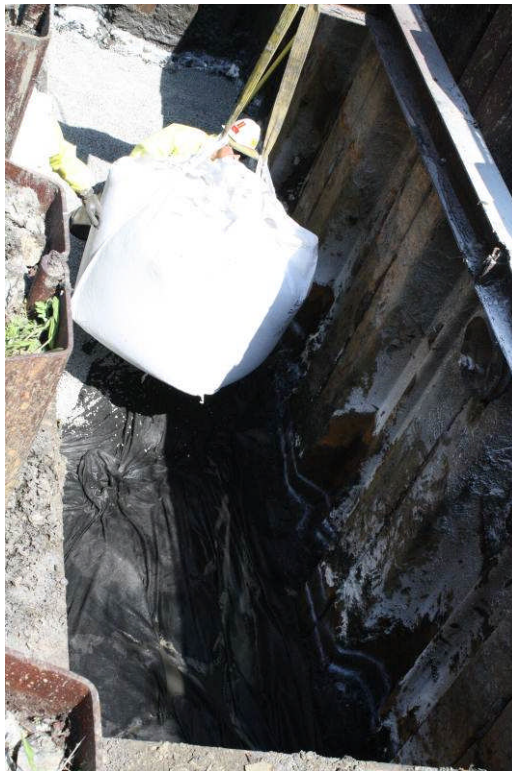
View of the AquaBlok® being poured in the confluence box.

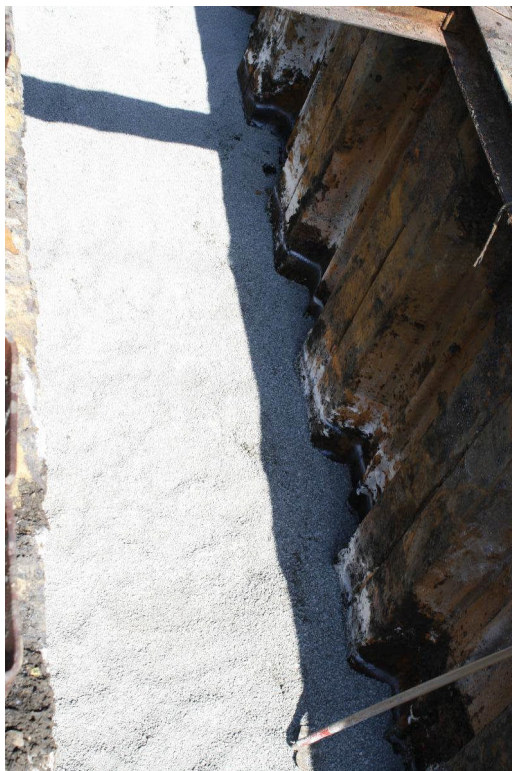
View of the minimum 6-inch thick AquaBlok® layer in the confluence box.

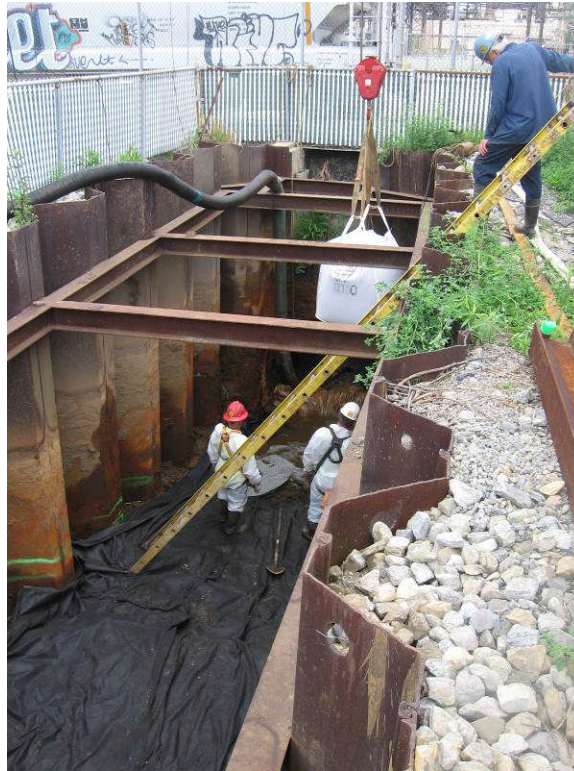
View of the placement of AquaBlok® in the upper sluiceway downstream of the subsurface concrete pipe.

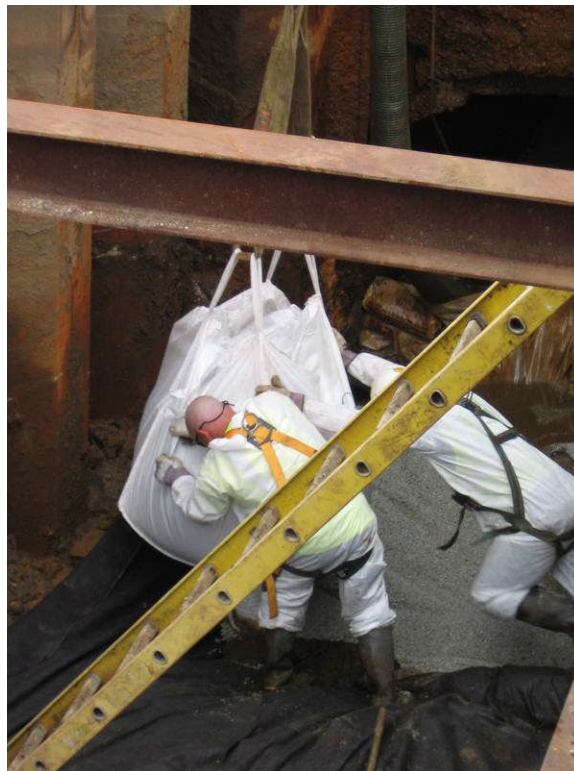
View of the placement of AquaBlok® in the upper sluiceway downstream of the subsurface concrete pipe.

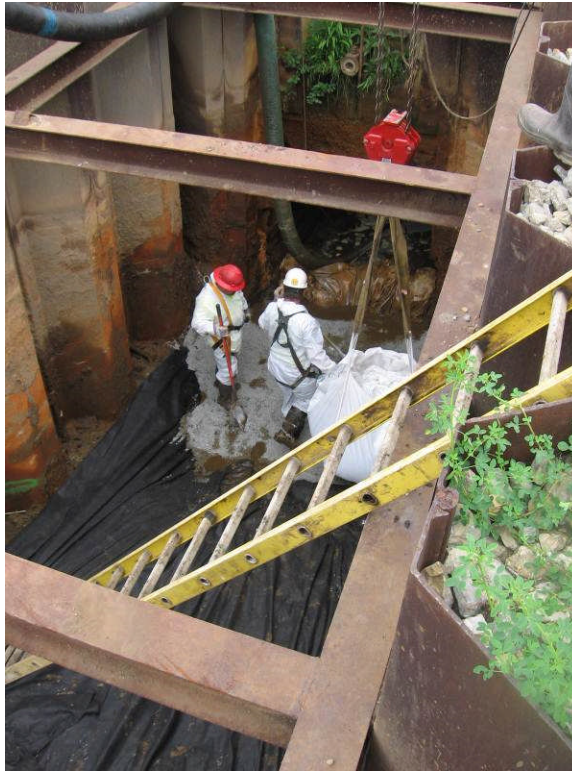
View of the placement of AquaBlok® in the upper sluiceway downstream of the subsurface concrete pipe.

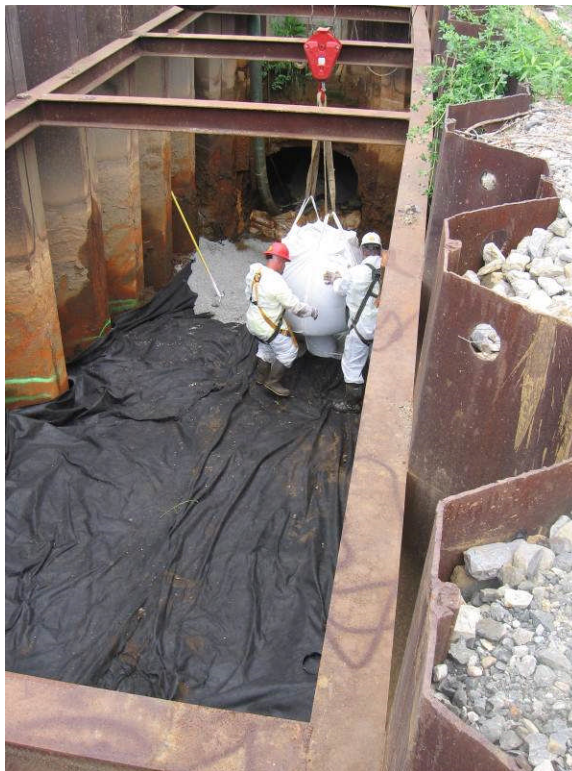
View of the placement of AquaBlok® in the upper sluiceway downstream of the subsurface concrete pipe.

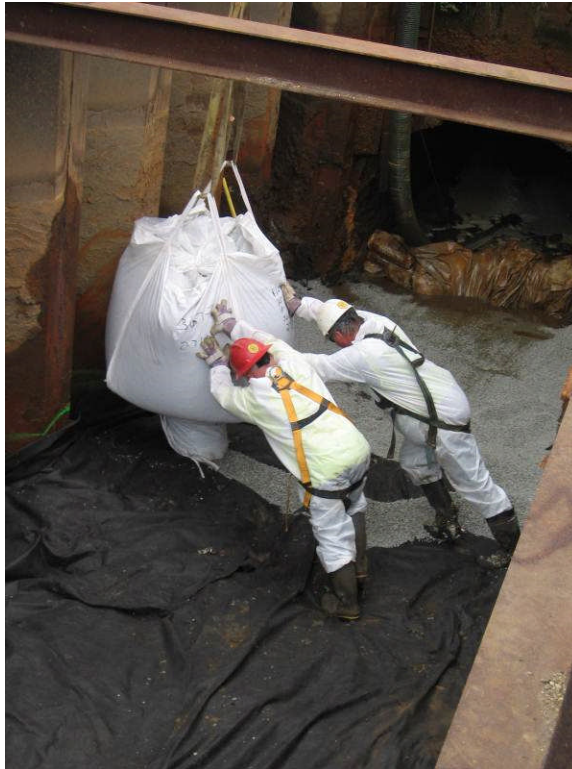
View of the placement of AquaBlok® in the upper sluiceway downstream of the subsurface concrete pipe.

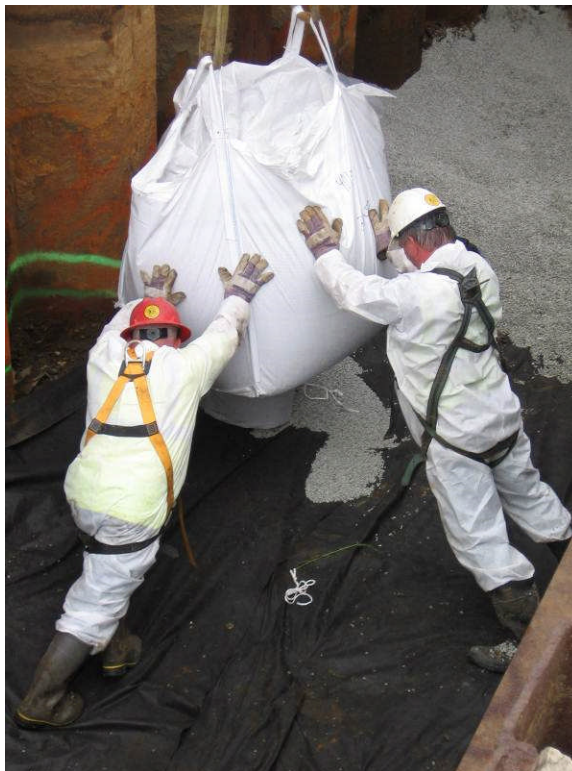
View of the placement of AquaBlok® in the upper sluiceway downstream of the subsurface concrete pipe.

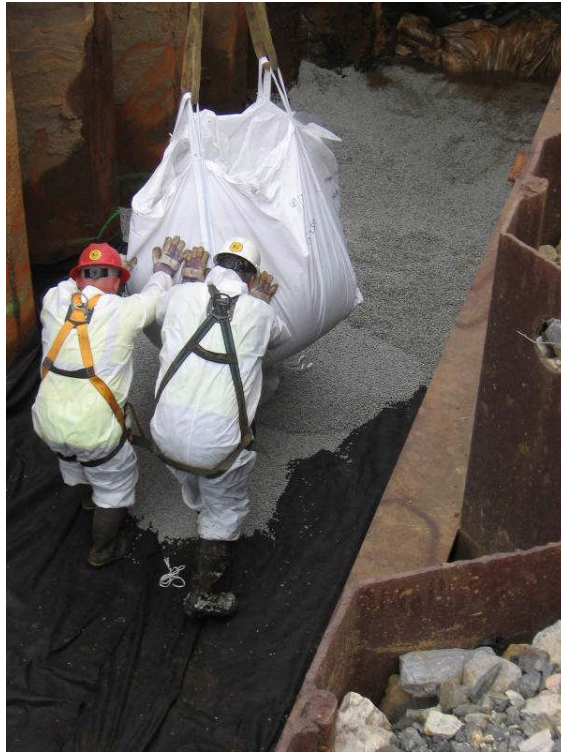
View of the placement of AquaBlok® in the upper sluiceway downstream of the subsurface concrete pipe.

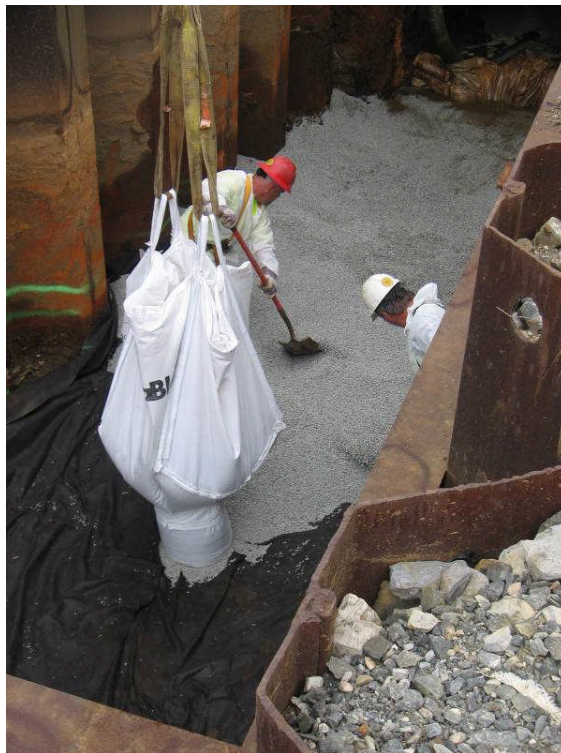
View of the minimum 6-inch thick AquaBlok® layer being placed downstream of the subsurface concrete pipe.

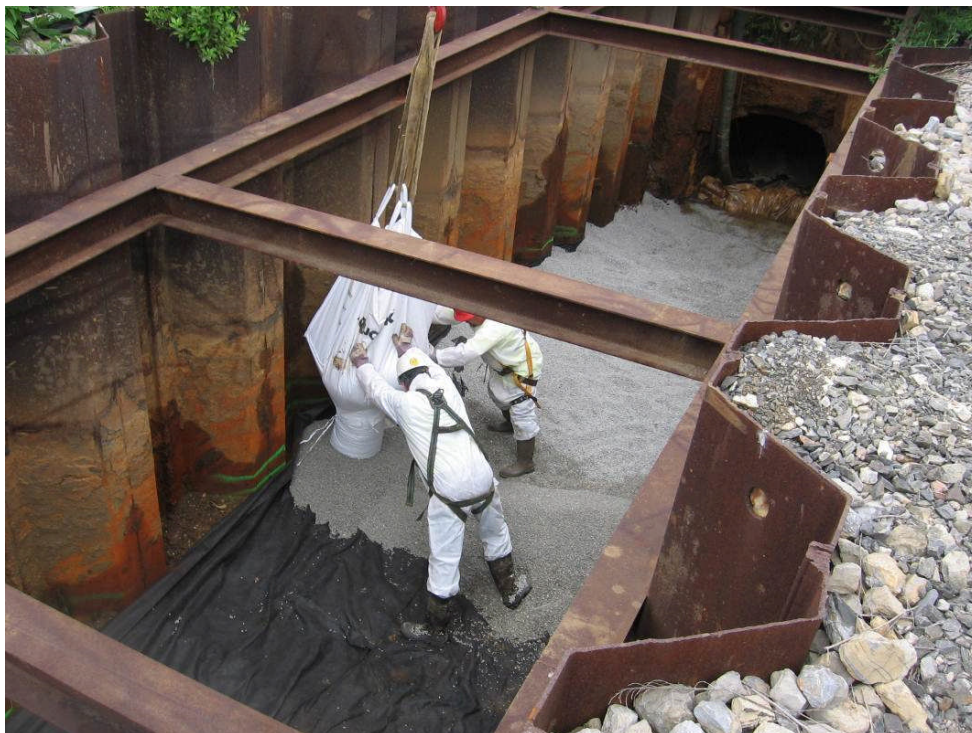
View of the minimum 6-inch thick AquaBlok® layer being placed downstream of the subsurface concrete pipe.

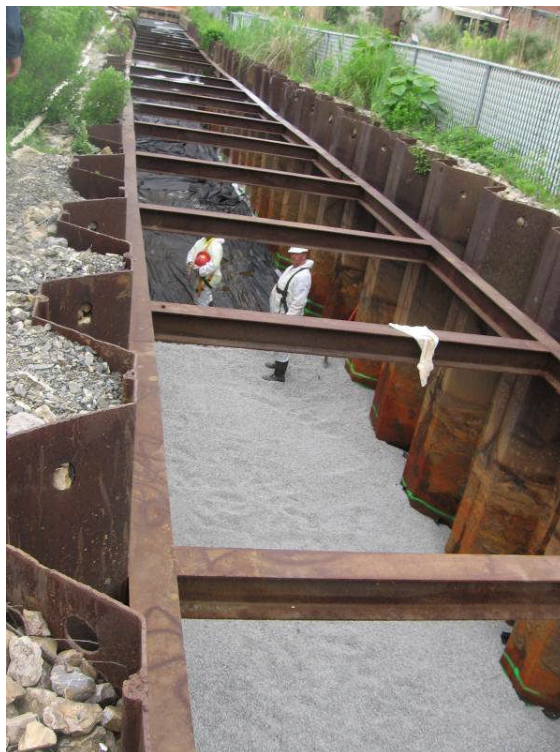
View of the minimum 6-inch thick AquaBlok® layer being placed downstream of the subsurface concrete pipe.

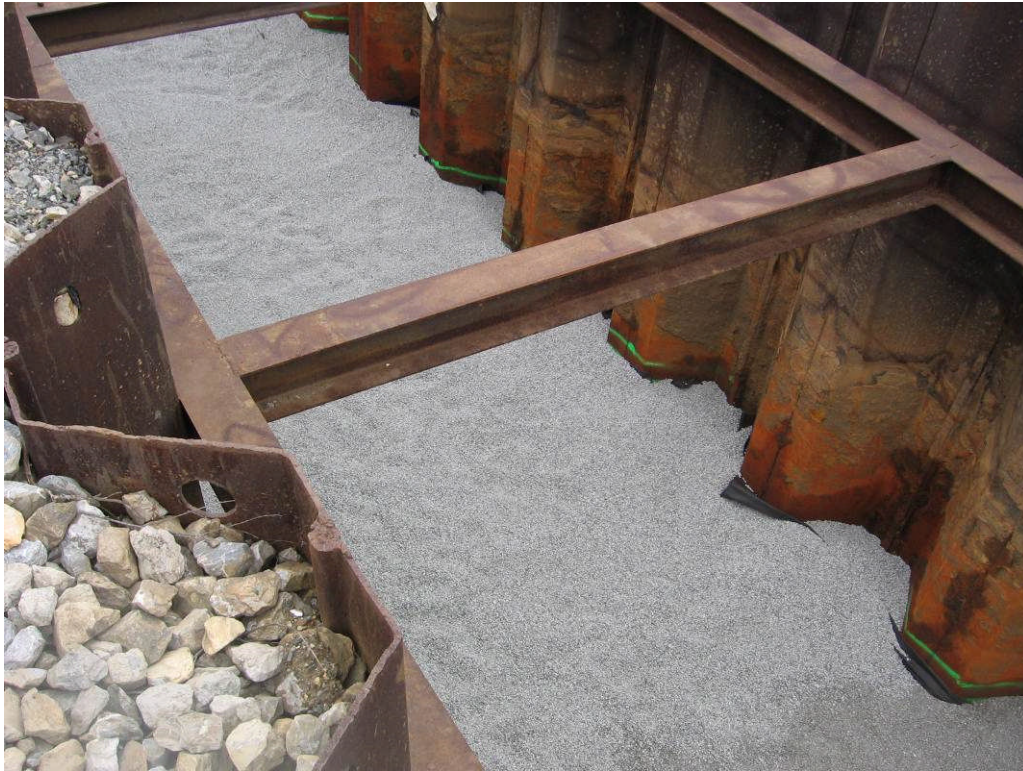
View of the minimum 6-inch thick AquaBlok® layer in the upper sluiceway.

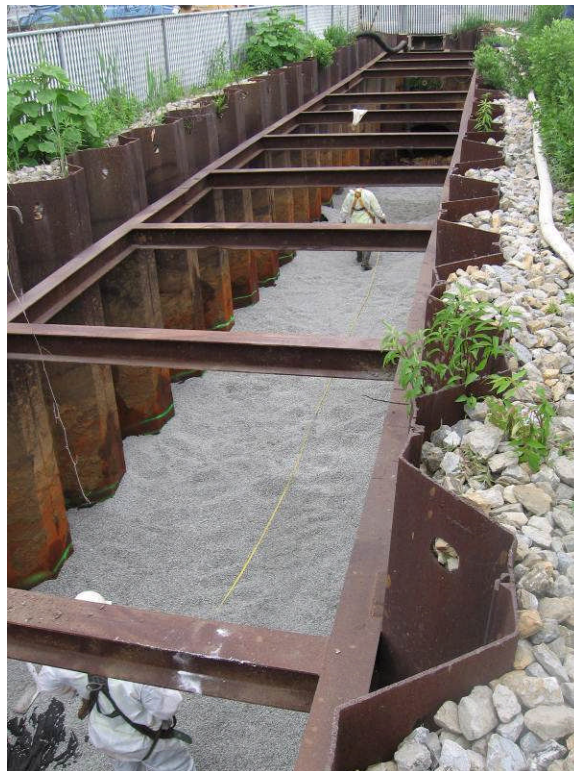
View of the minimum 6-inch thick AquaBlok® layer in the upper sluiceway.

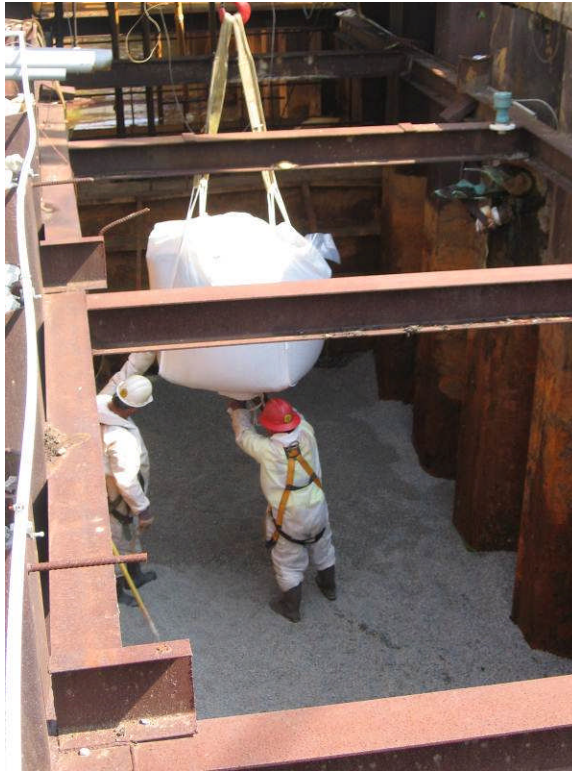
View of the AquaBlok® being placed in the upper sluiceway upstream of the weir.
